**Promontory Point in Burnham Park**

54<sup>th</sup> to 57<sup>th</sup> Streets in Chicago, Illinois

April 14, 2003 – Preliminary for Review

The Hyde Park Community's Proposal for the Preservation, Restoration and Enhancement of the Historic Stepped Limestone Revetment System at Promontory Park

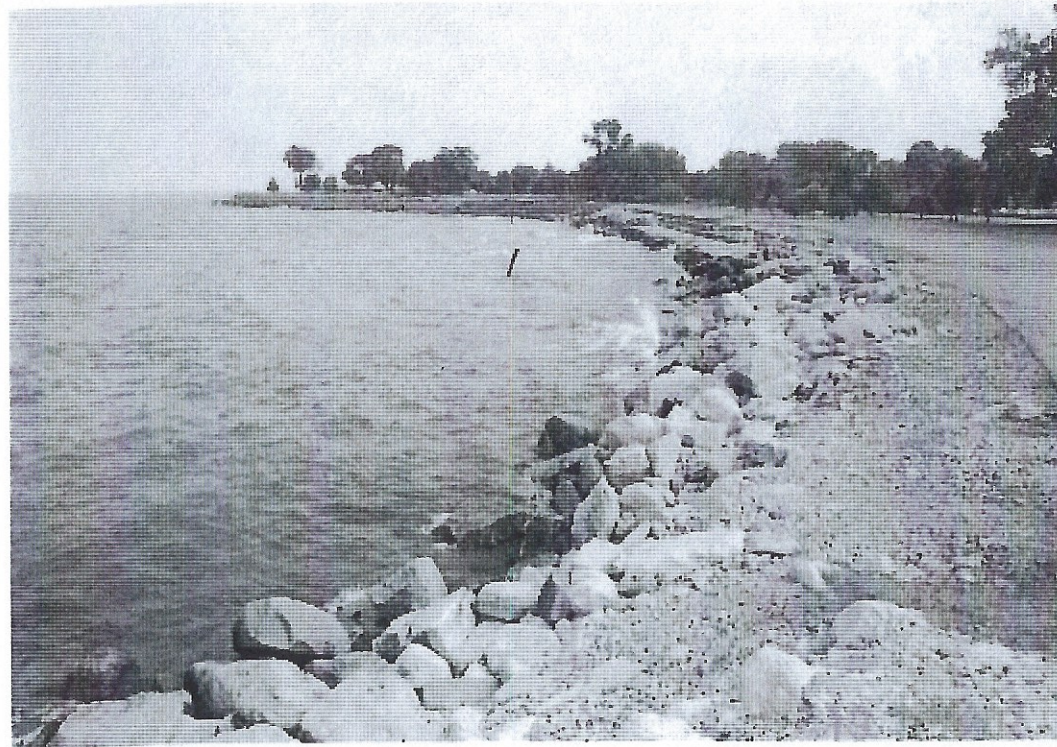
### **Segment A**

Transition segment between new concrete and restored stone revetment

Integrates storm drainage gap with accessible ramp to promenade level from park

Maintains natural features of Promontory Point

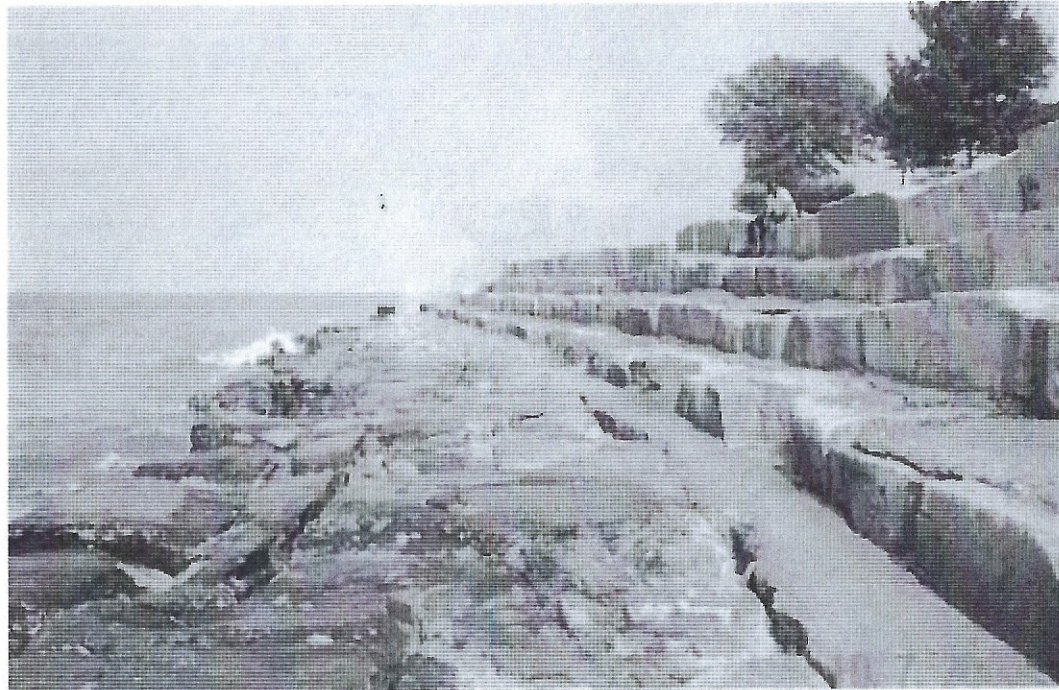
**Segment B**

Unique water recreation feature of “submerged beach”

Accessible ramp and stairs from promenade level to “submerged beach”

Stairs for access from park to promenade level

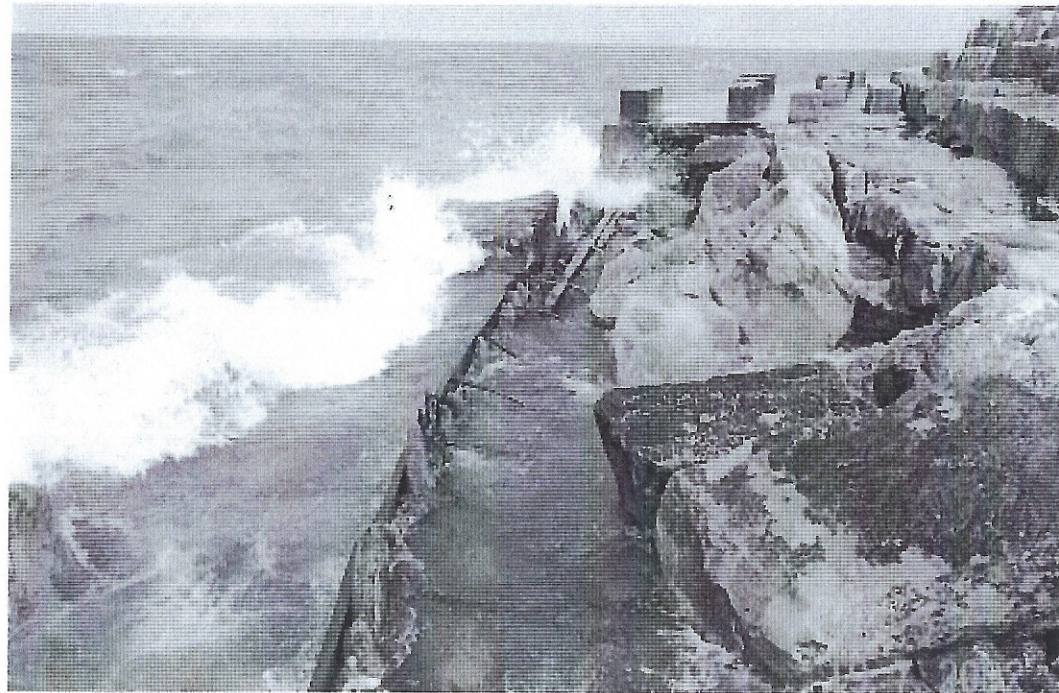
### **Segment C**

Concrete platform is repaired and retained, voids grouted full

New stone edge

Exposed wood piling in front of sheet piling

Stairs and accessible ramp integrated into revetment for access from field house to promenade level

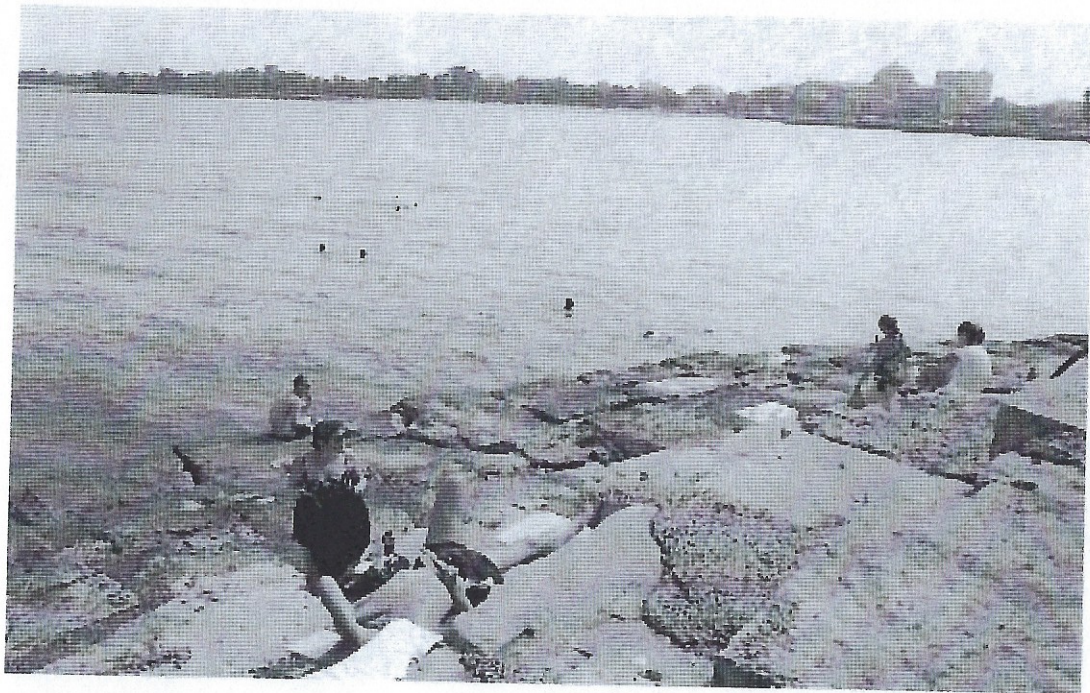
**Segment D**

Stairs from meadow to promenade level

Exposed wood piling in front of sheet piling

Stairs integrated into revetment from promenade level to water for access

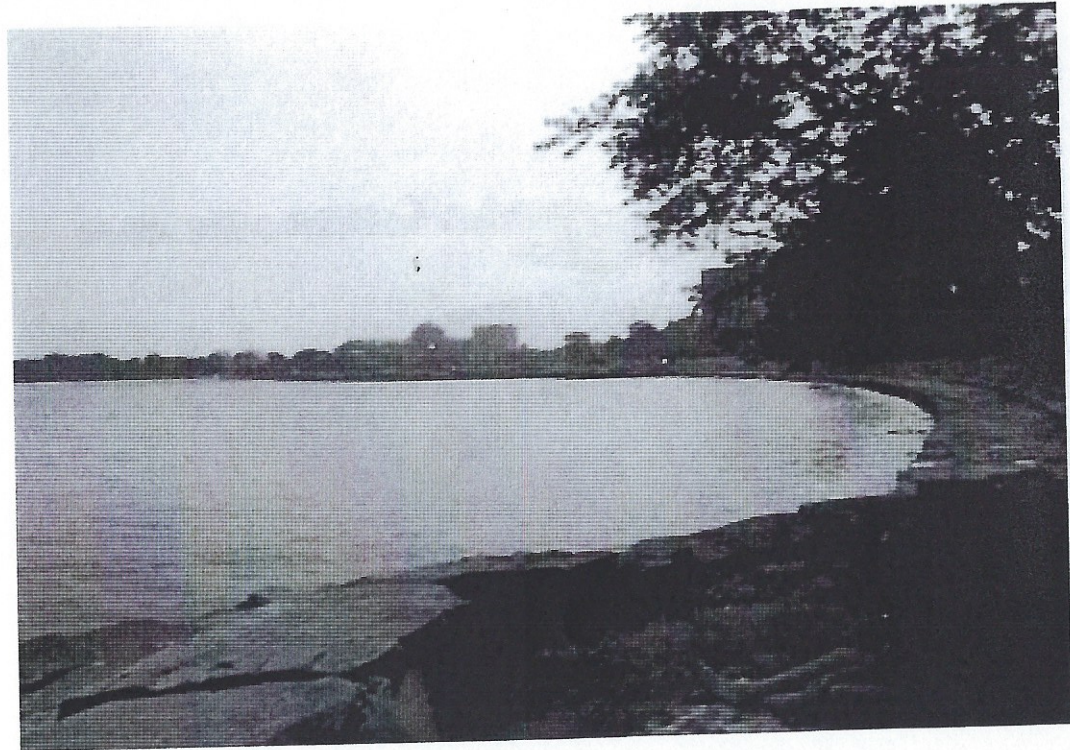
**Segment F**

Transition segment between new concrete and restored stone revetment

Integrates storm drainage gap with accessible ramp to promenade level from park

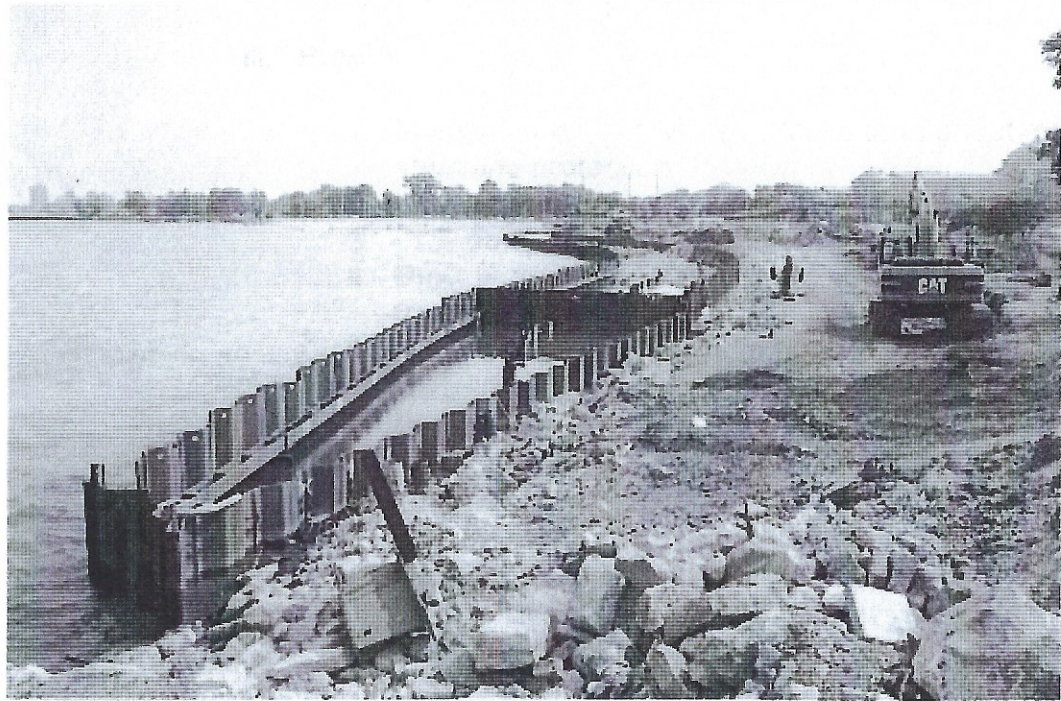
**Segment SX**

Concrete promenade and revetment currently under construction to the south
